RE: GOH Infrastructure Matrix

1) Sight surveys of the structural integrity of 22 GOH office building were undertaken on January 20 & 21, 2010.

## Pictorial Inventory

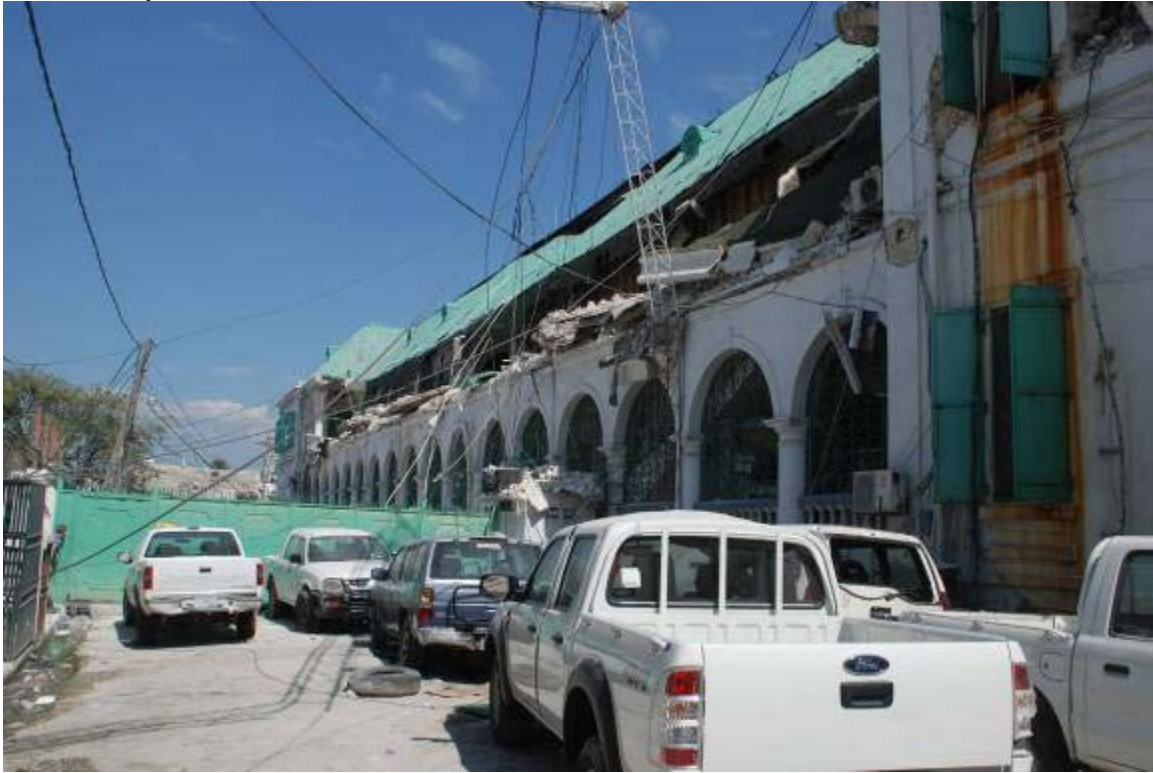
### 1) Ministry of Finance

The Ministry of Finance had major infrastructure damage, visual evidence of the **partial collapse** of front of building and interior floors and ceilings, and damage to the roof. Unsafe to enter.

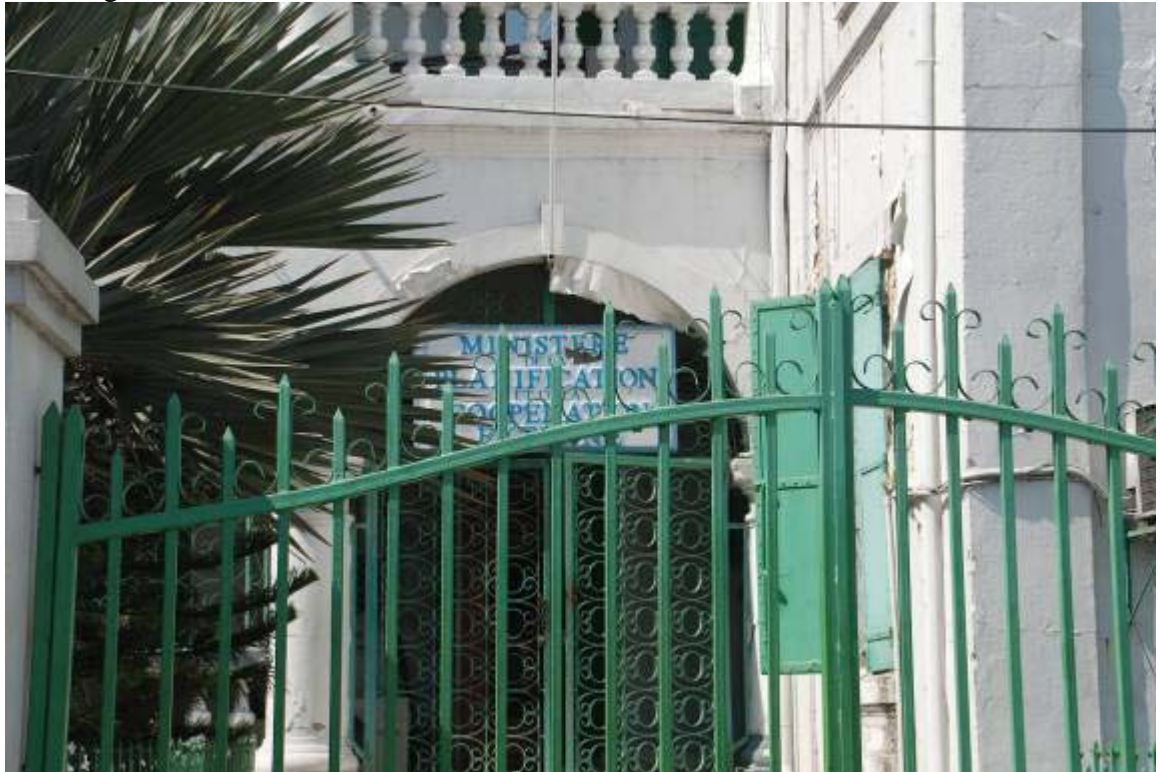
2) Ministry of Planning

The Ministry of Planning remains standing (Front) but the visual outside inspection of building revealed serious cracks and stress to the entire building and partial interior collapsed floors.

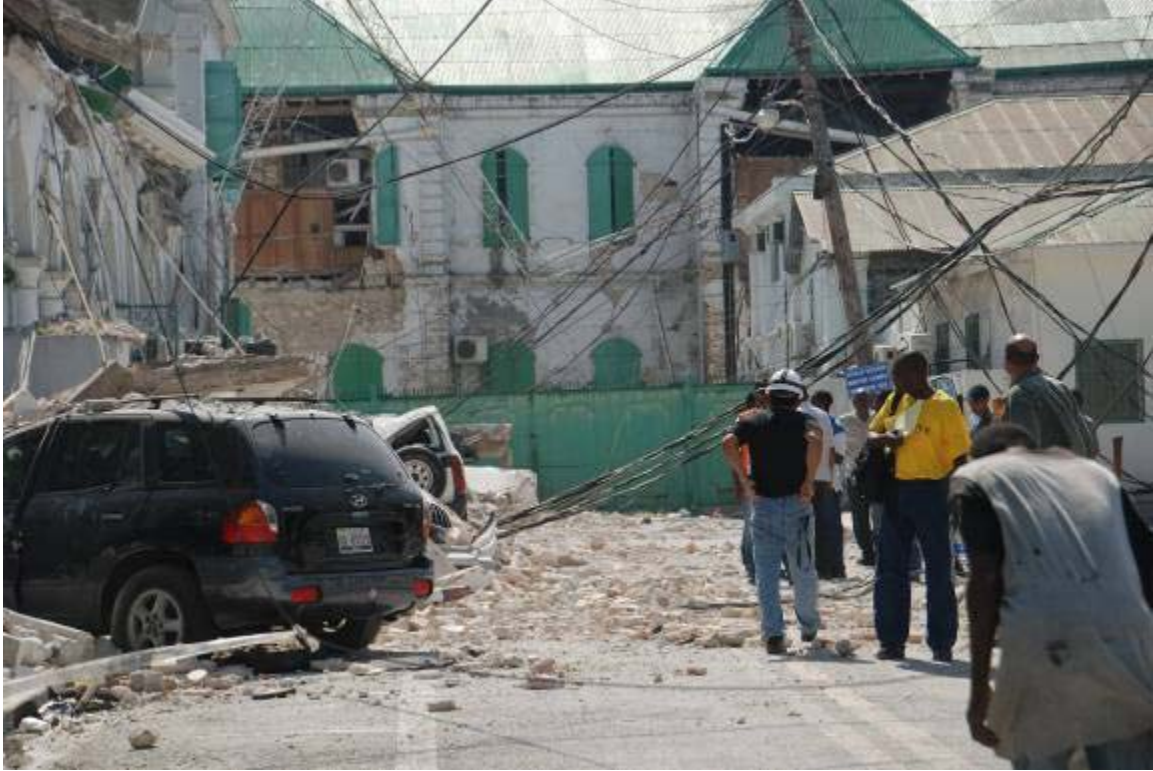
The Ministry of Planning (from rear of building)

**Partial collapse** of rear of building and interior floors and ceilings, and damage to the roof. Unsafe to enter.

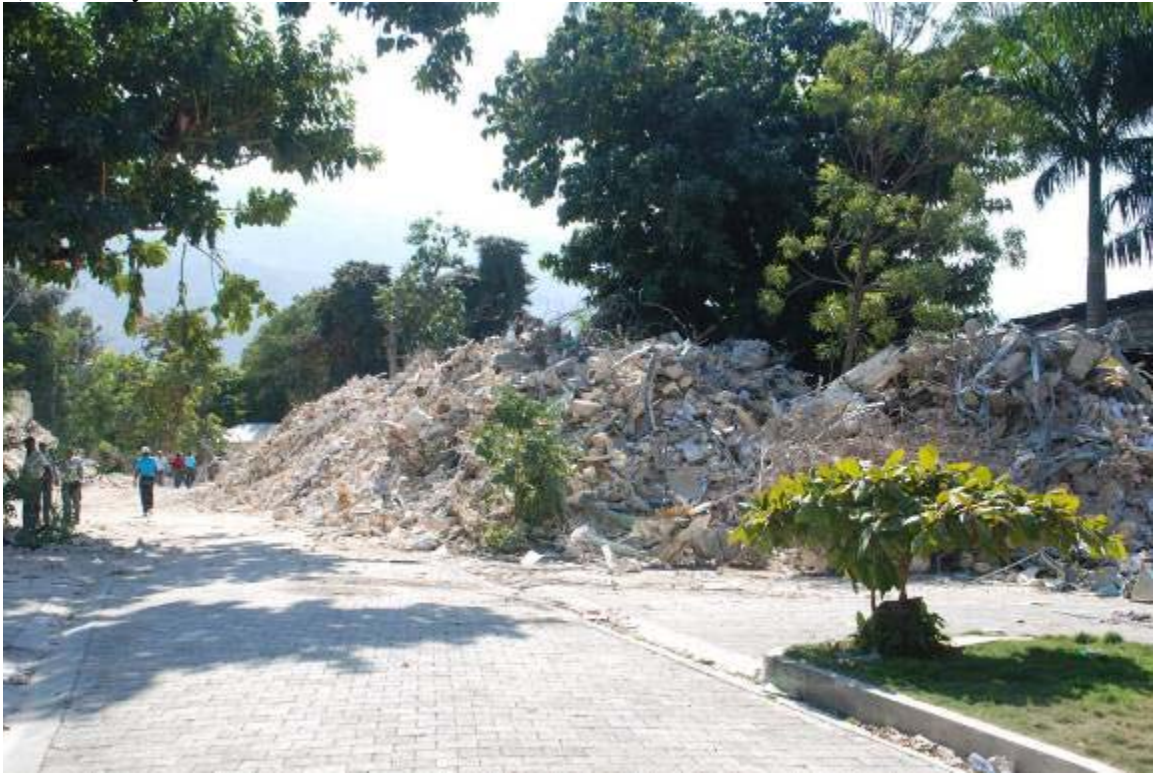
### 3) Ministry of Justice

The Ministry of Justice has completely collapsed, crews began demolition.

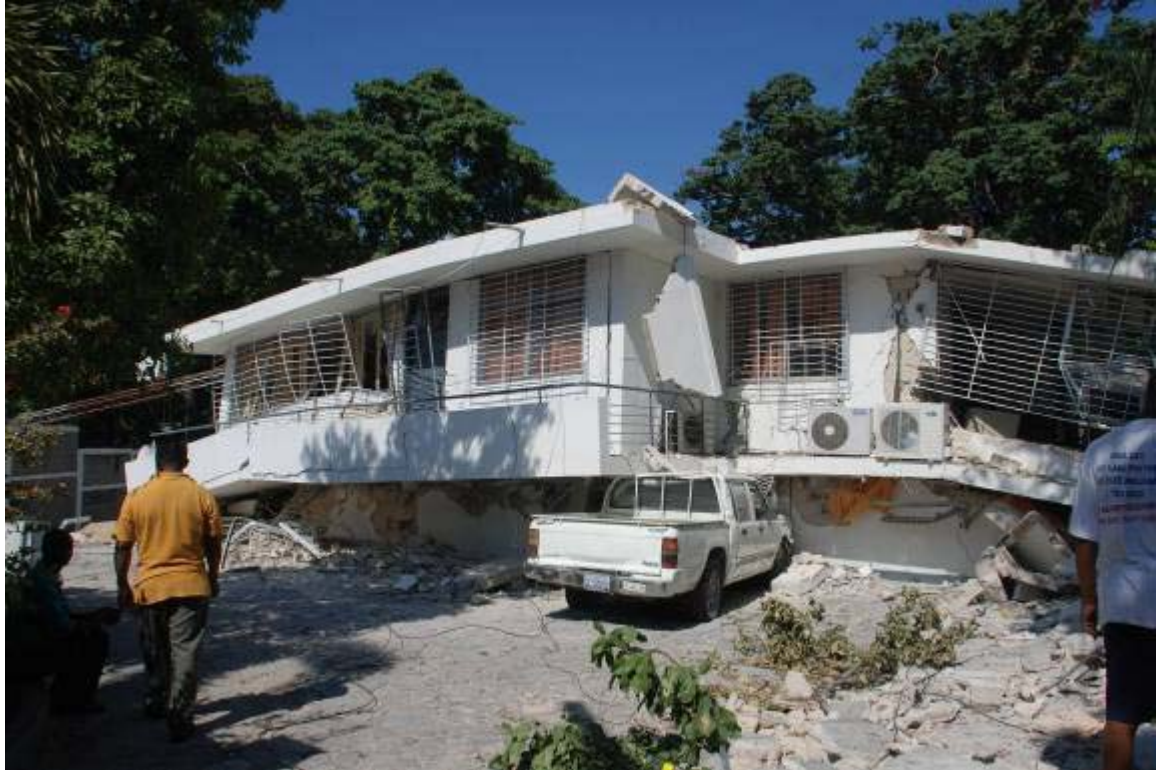
4) Ministry of Haitians  
Abroad

The Ministry for Haitians Abroad: severe structural damage, the building has collapsed in several sections. Unsafe to enter.

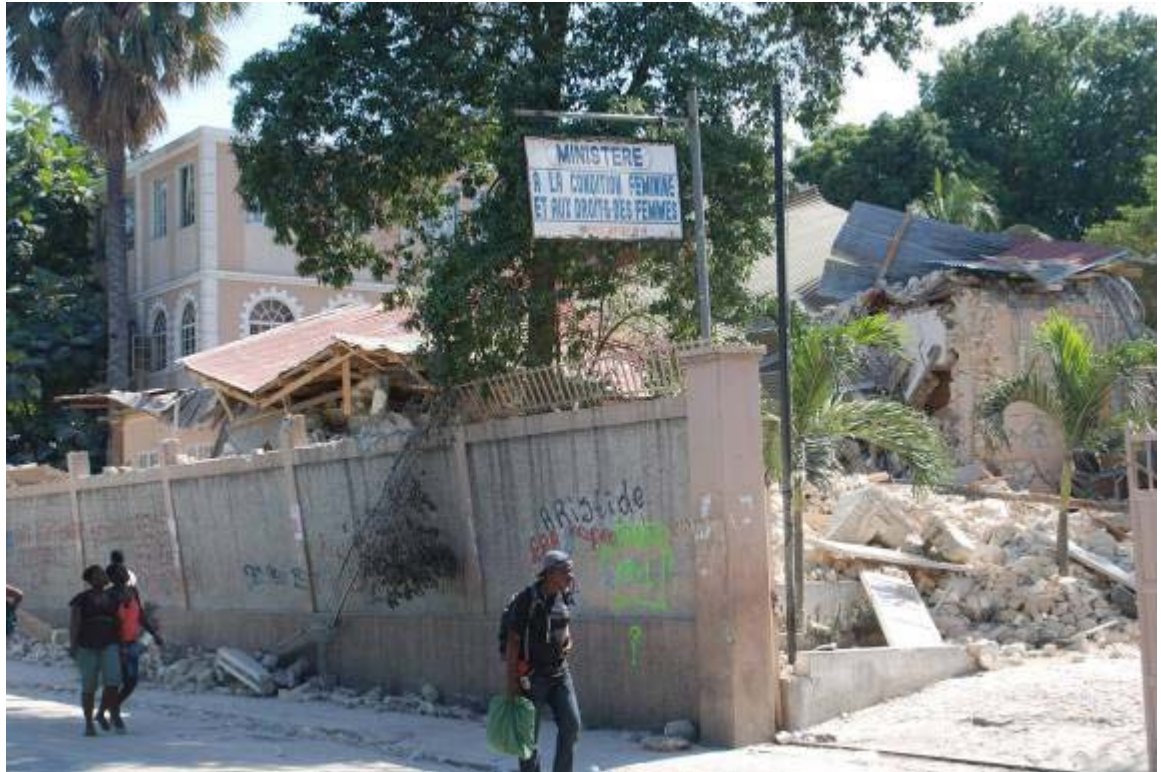
5) The Ministry For Women's Affairs

The Ministry for Women's Affairs has totally collapsed.

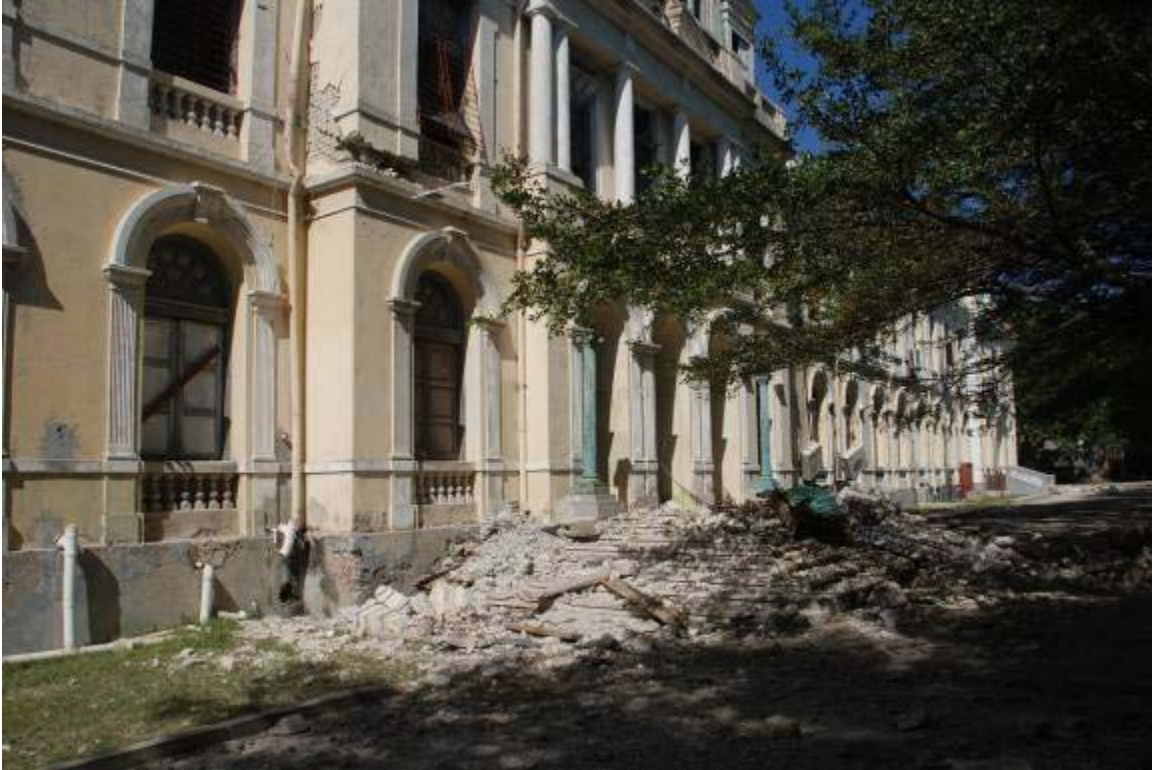
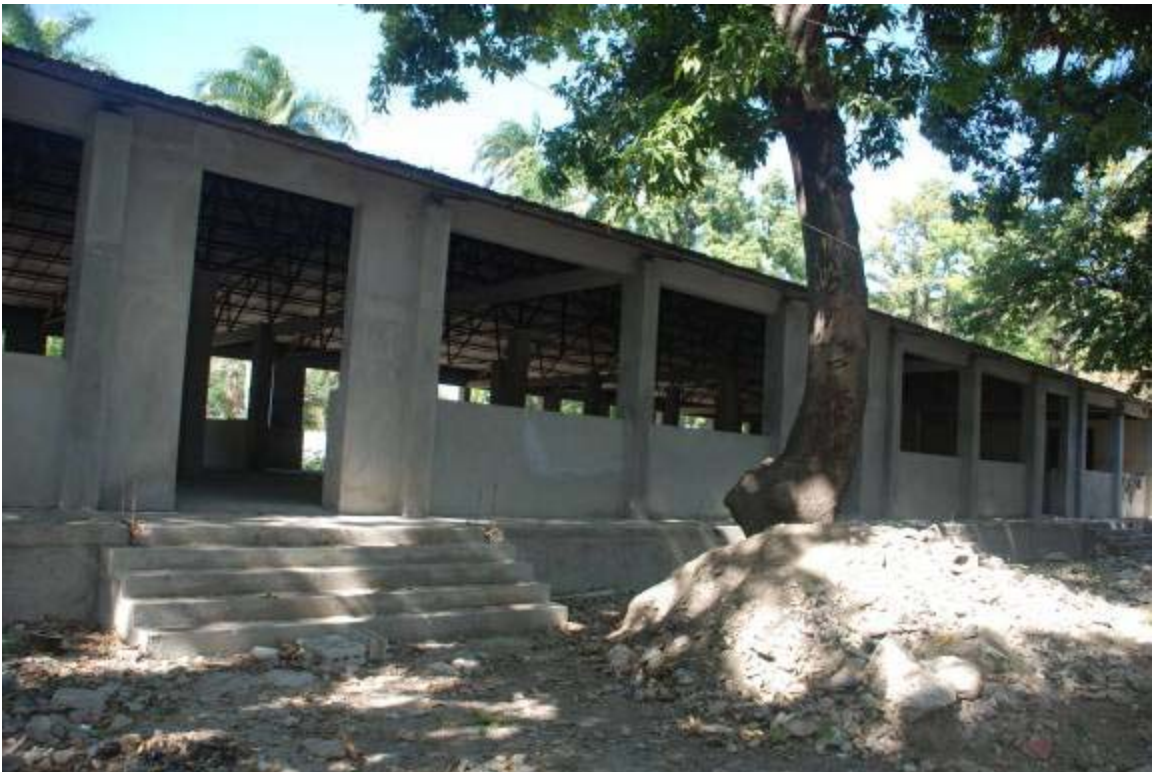
6) The Ministry for Agriculture

The Ministry of Agriculture's main building displayed large cracks on the exterior of the building and major stress at joints. There are several outer buildings that seemed to have suffered minor damages, with one new building under construction (pictured) that appeared intact.

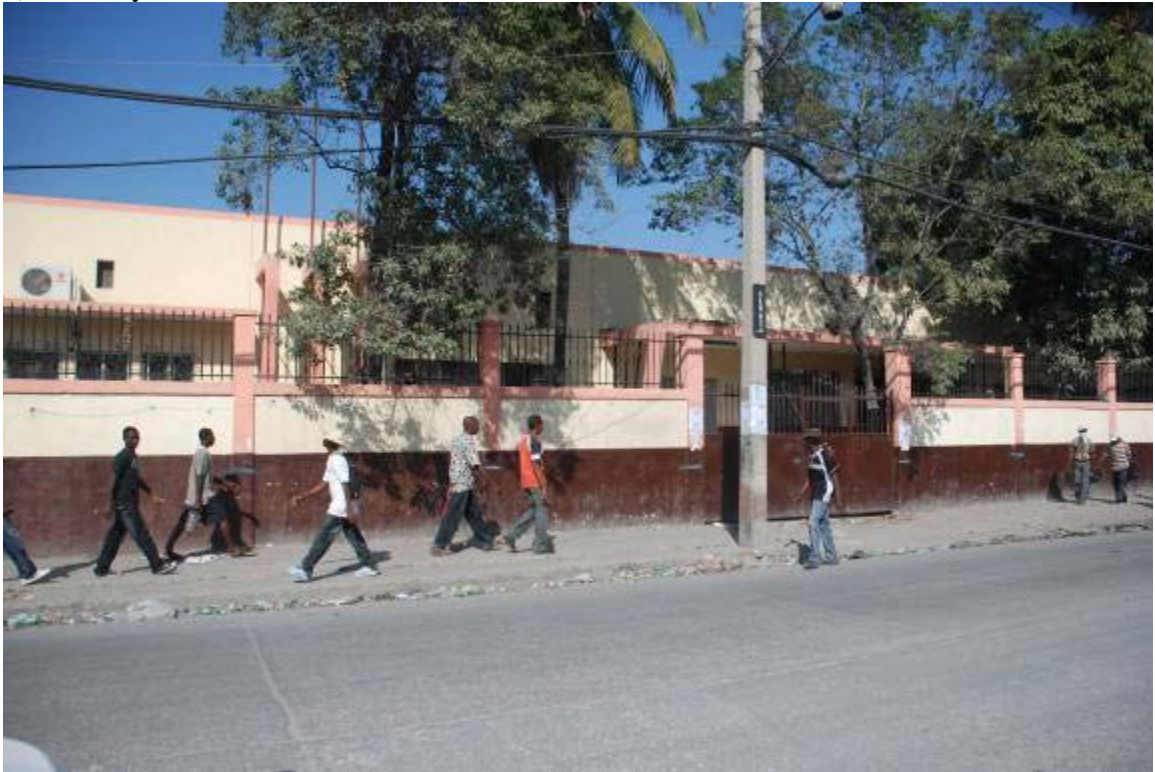
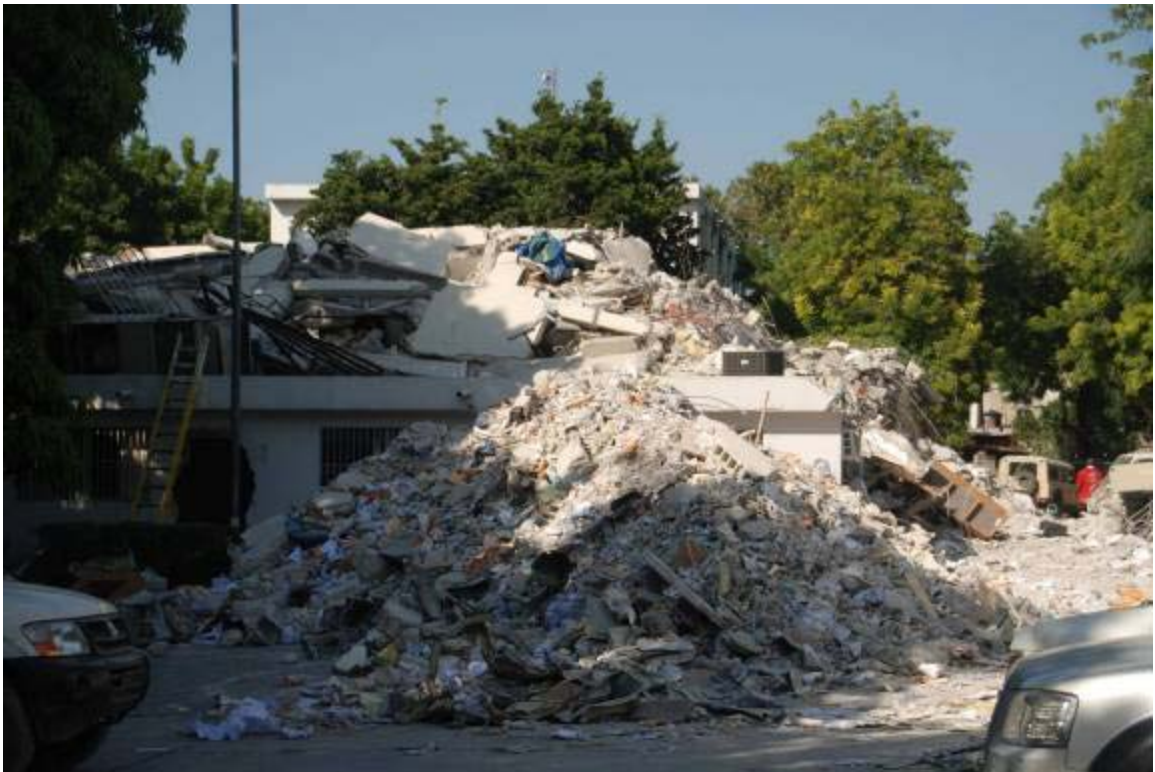
## 7) Ministry for Education

The main building of the Ministry of Education collapsed in several sections, demolition had begun. A second MOE building near the waterfront appeared intact (was unable to gain access)

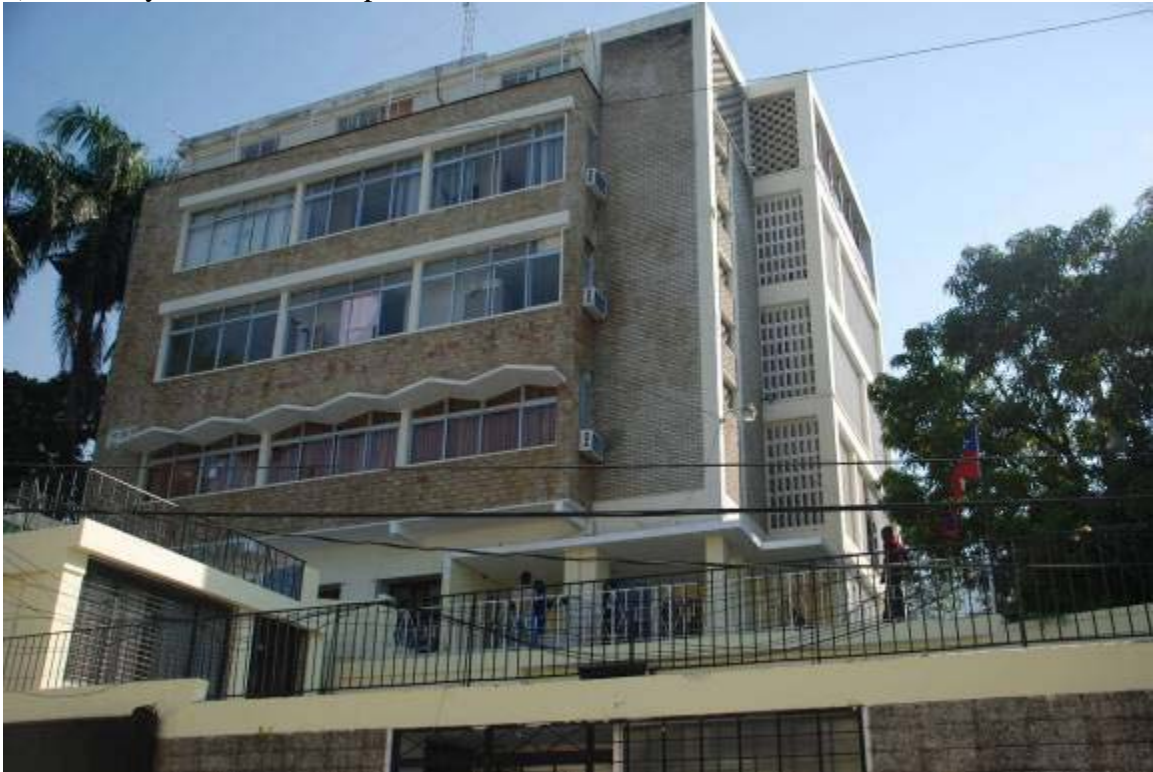
8) Ministry of Youth and Sport

Ministry of Youth and Sport did not appear to have major structural damage. Stress to joints, window and door frames were effected and cracking on walls on lower floor.

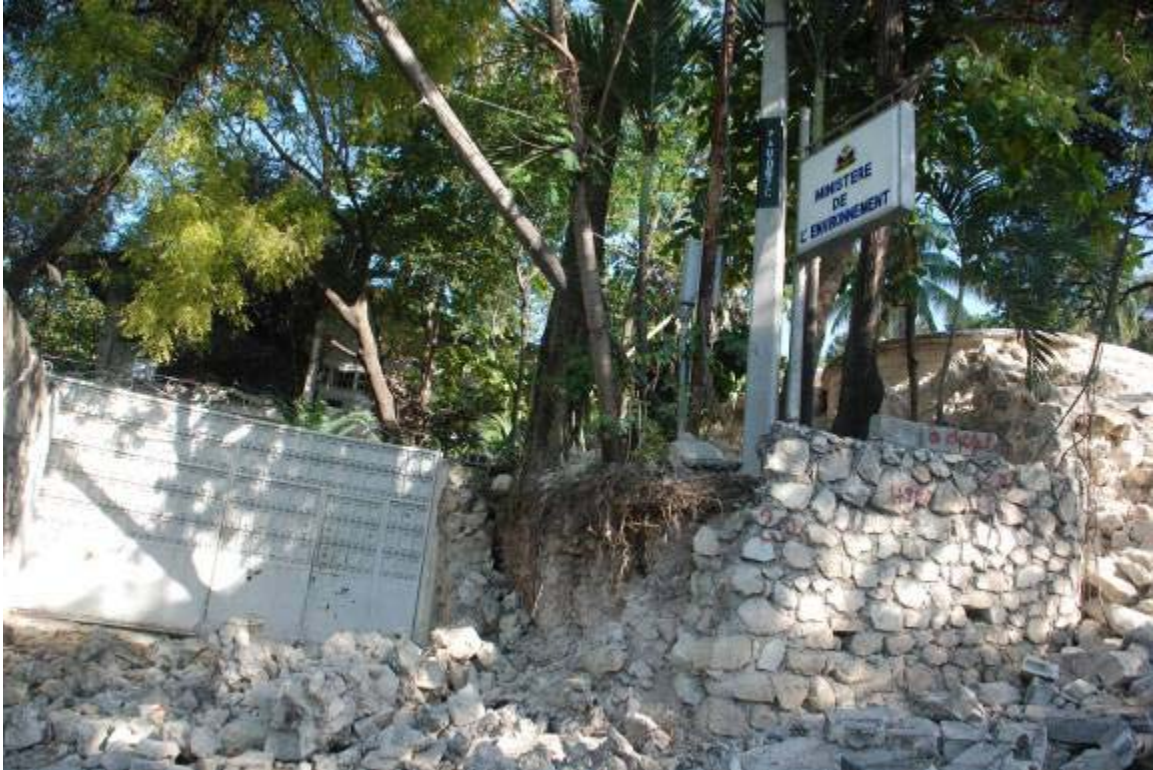
## 9) Ministry for Environment

Ministry for Environment showed evidence of major structural damage and collapsed sections. Unable to gain access because of rubble to egress areas.

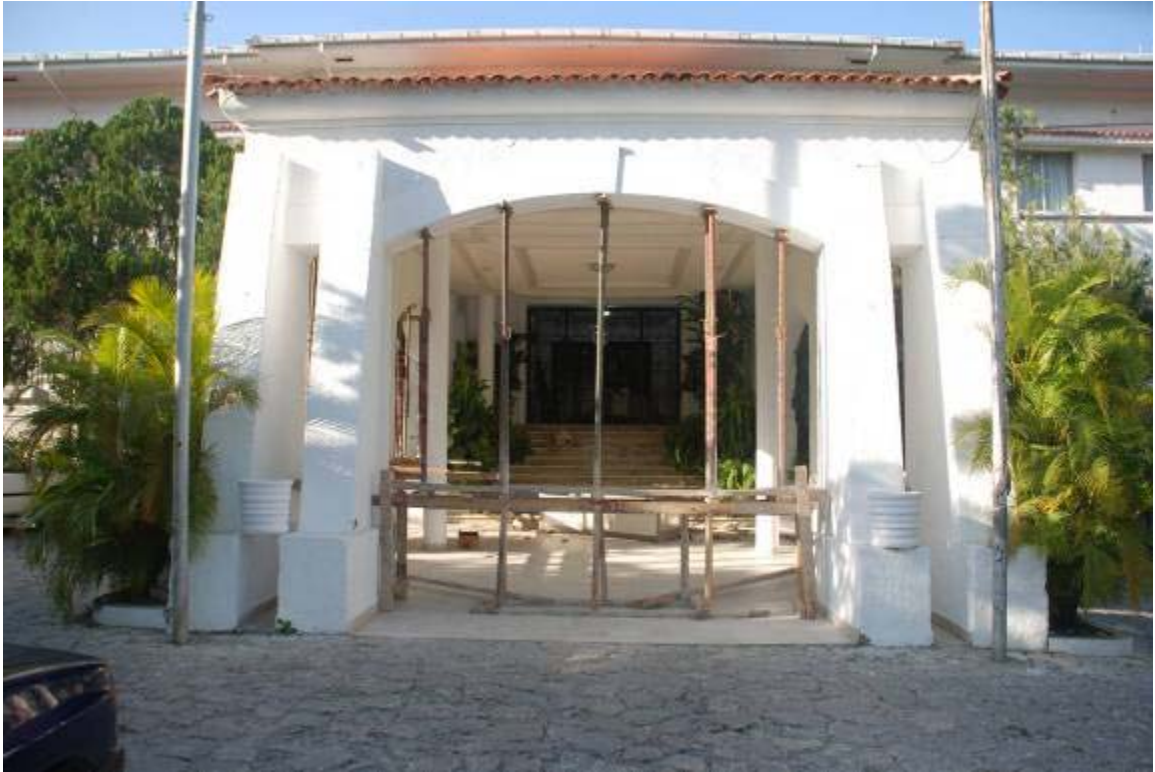
10) Office of the Prime Minister (Home Office for the Minister for Executive/Parliament relations)

The Office of the Prime Minister evidenced structural cracks, apparent shifting of the foundation, and other instances of stress. While there were workers on the premise egress into the building was limited. Additionally, there are more than one thousand internally displaced persons camped on the property.

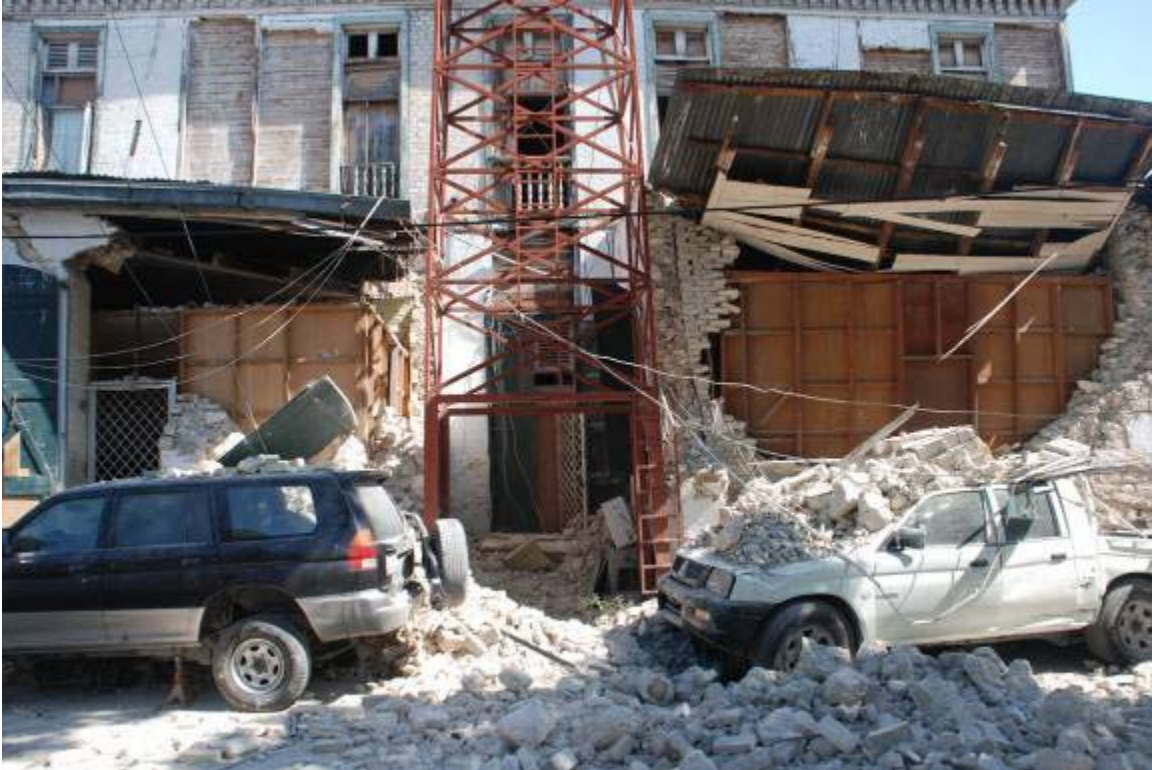
## 11) The Ministry for Social Welfare

The Ministry for Social Welfare had major structural damage including collapsed walls and floors.

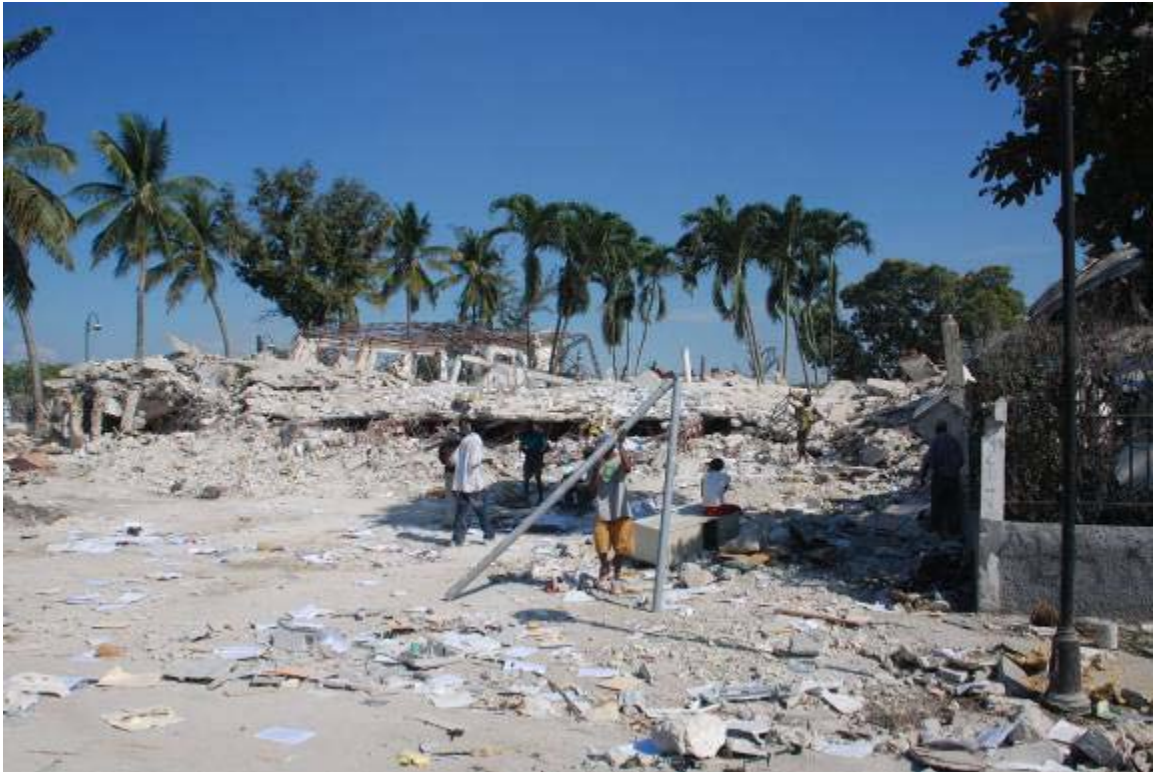
12) The Ministry for Foreign Affairs

The Ministry for Foreign Affairs has completely collapsed, crews began demolition

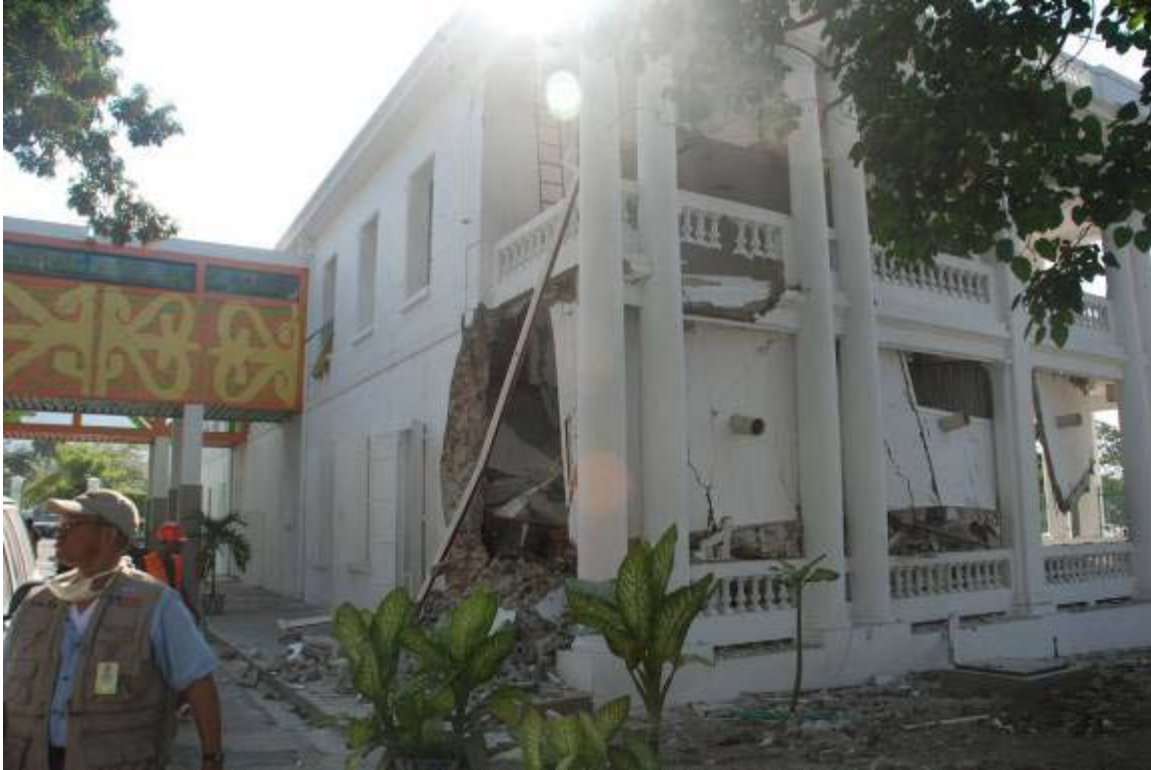
13) The Ministry for Culture and Communications

The Ministry for Culture and Communications evidenced major cracks and partial collapse of front wall and floors.

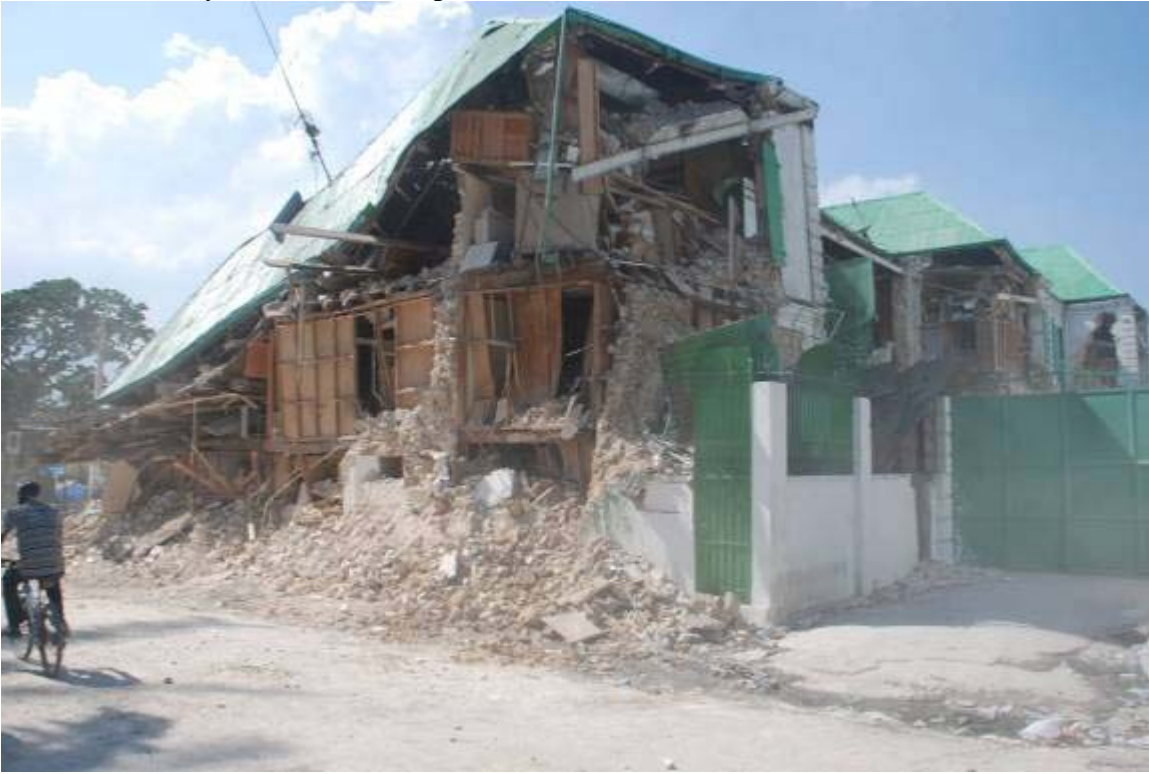
14) The Ministry for Health & Population

The Ministry for Health & Population's exterior walls has collapsed.

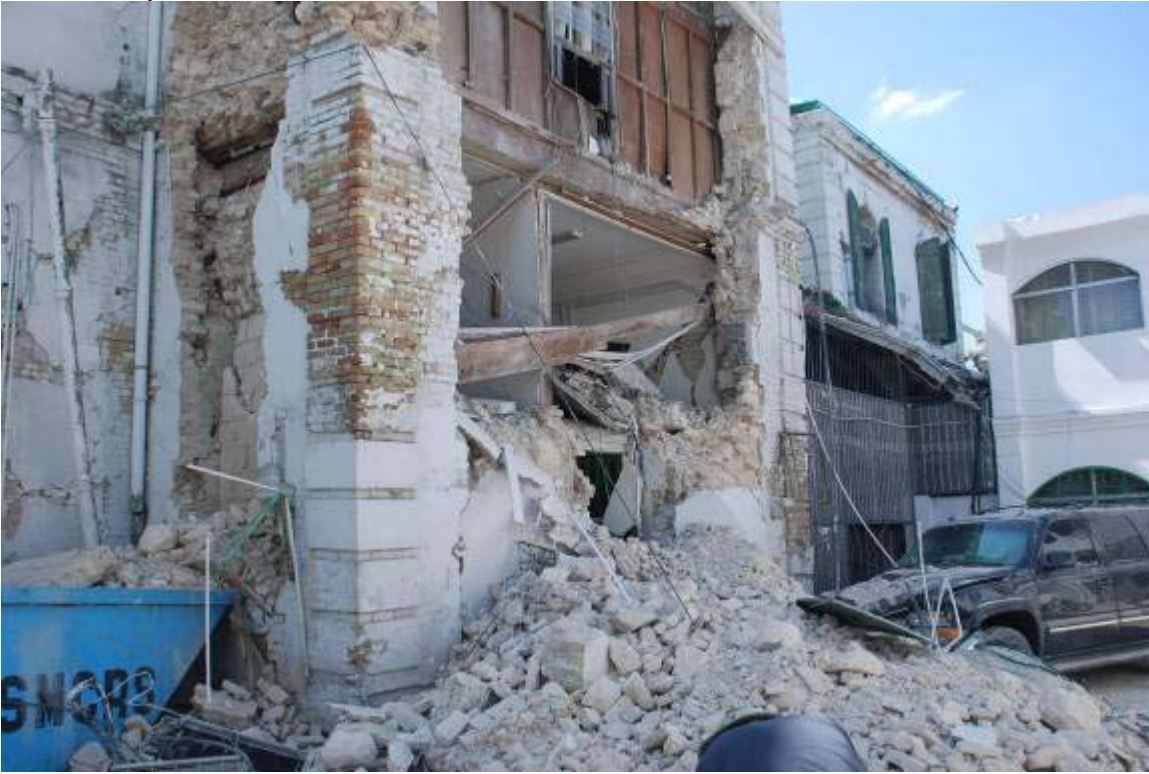
16) Ministry of Interior

Ministry of Interior suffered major structural damage with exterior walls collapsing.

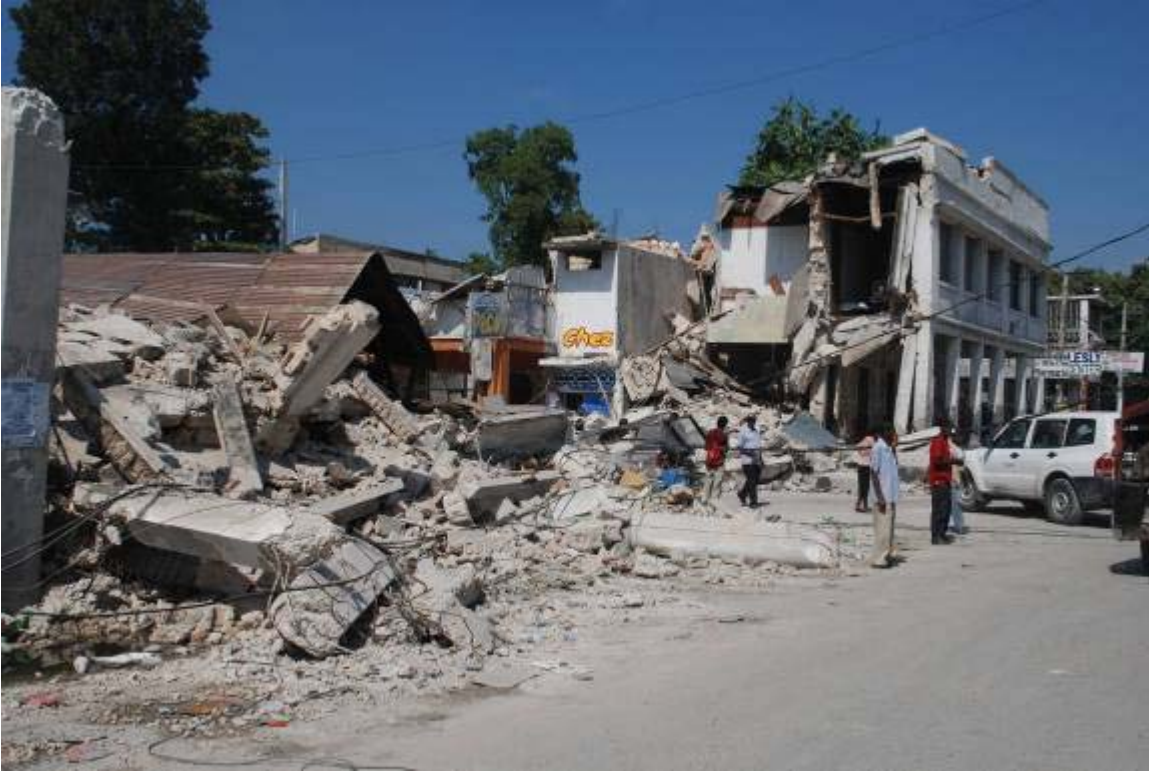
17) Bureau of Tax

Bureau of Tax has collapsed

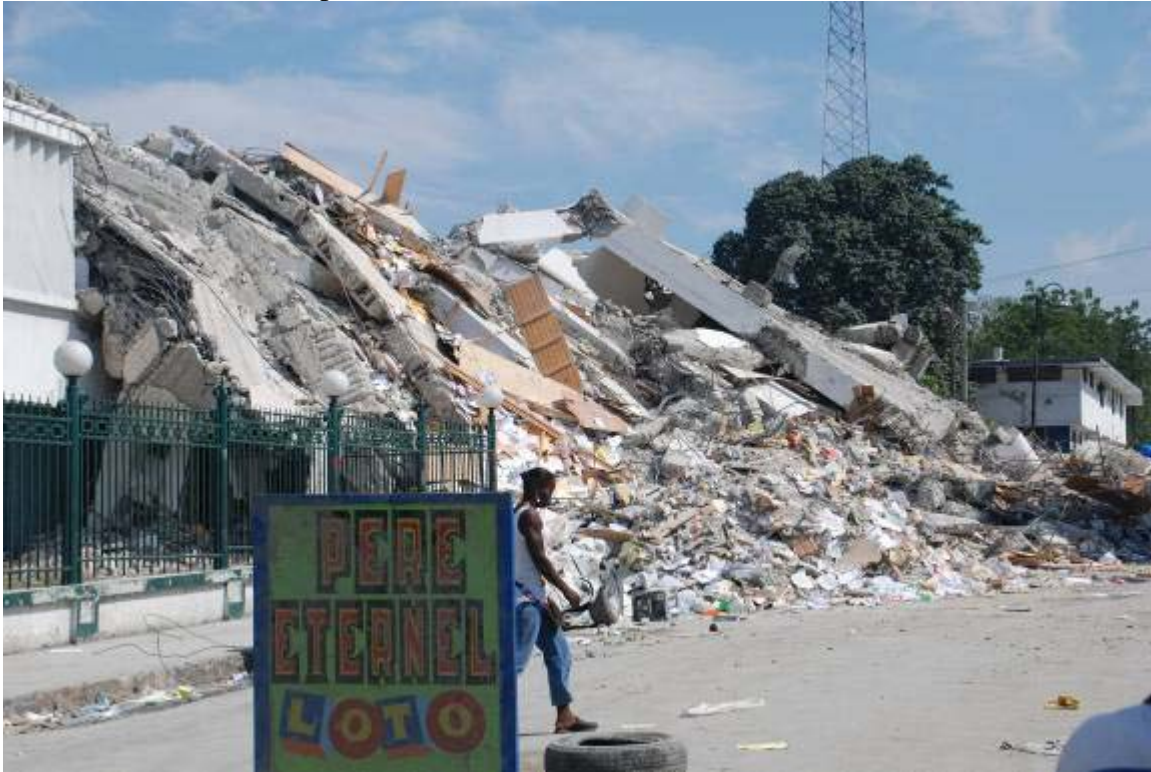
18) Palace of Justice (Supreme Court)

Palace of Justice has collapsed

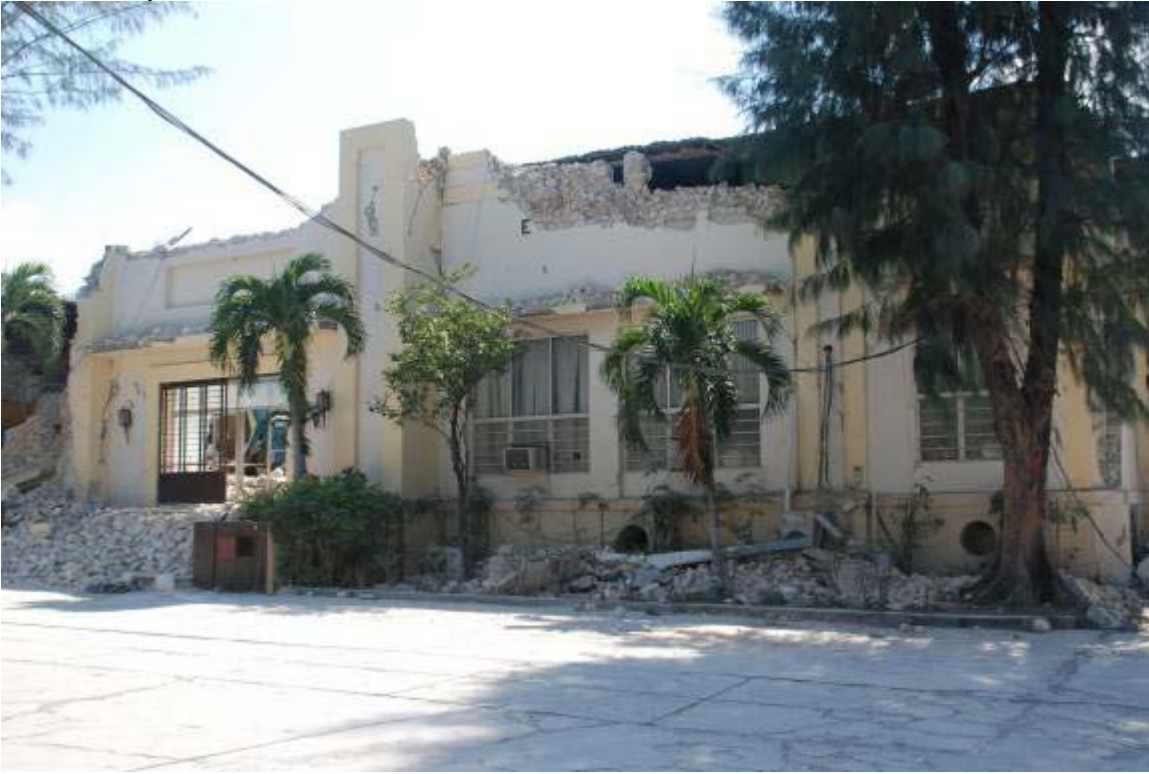
19) Ministry of Commerce

Ministry of Commerce suffered major structural damage with exterior walls and roof collapsing.

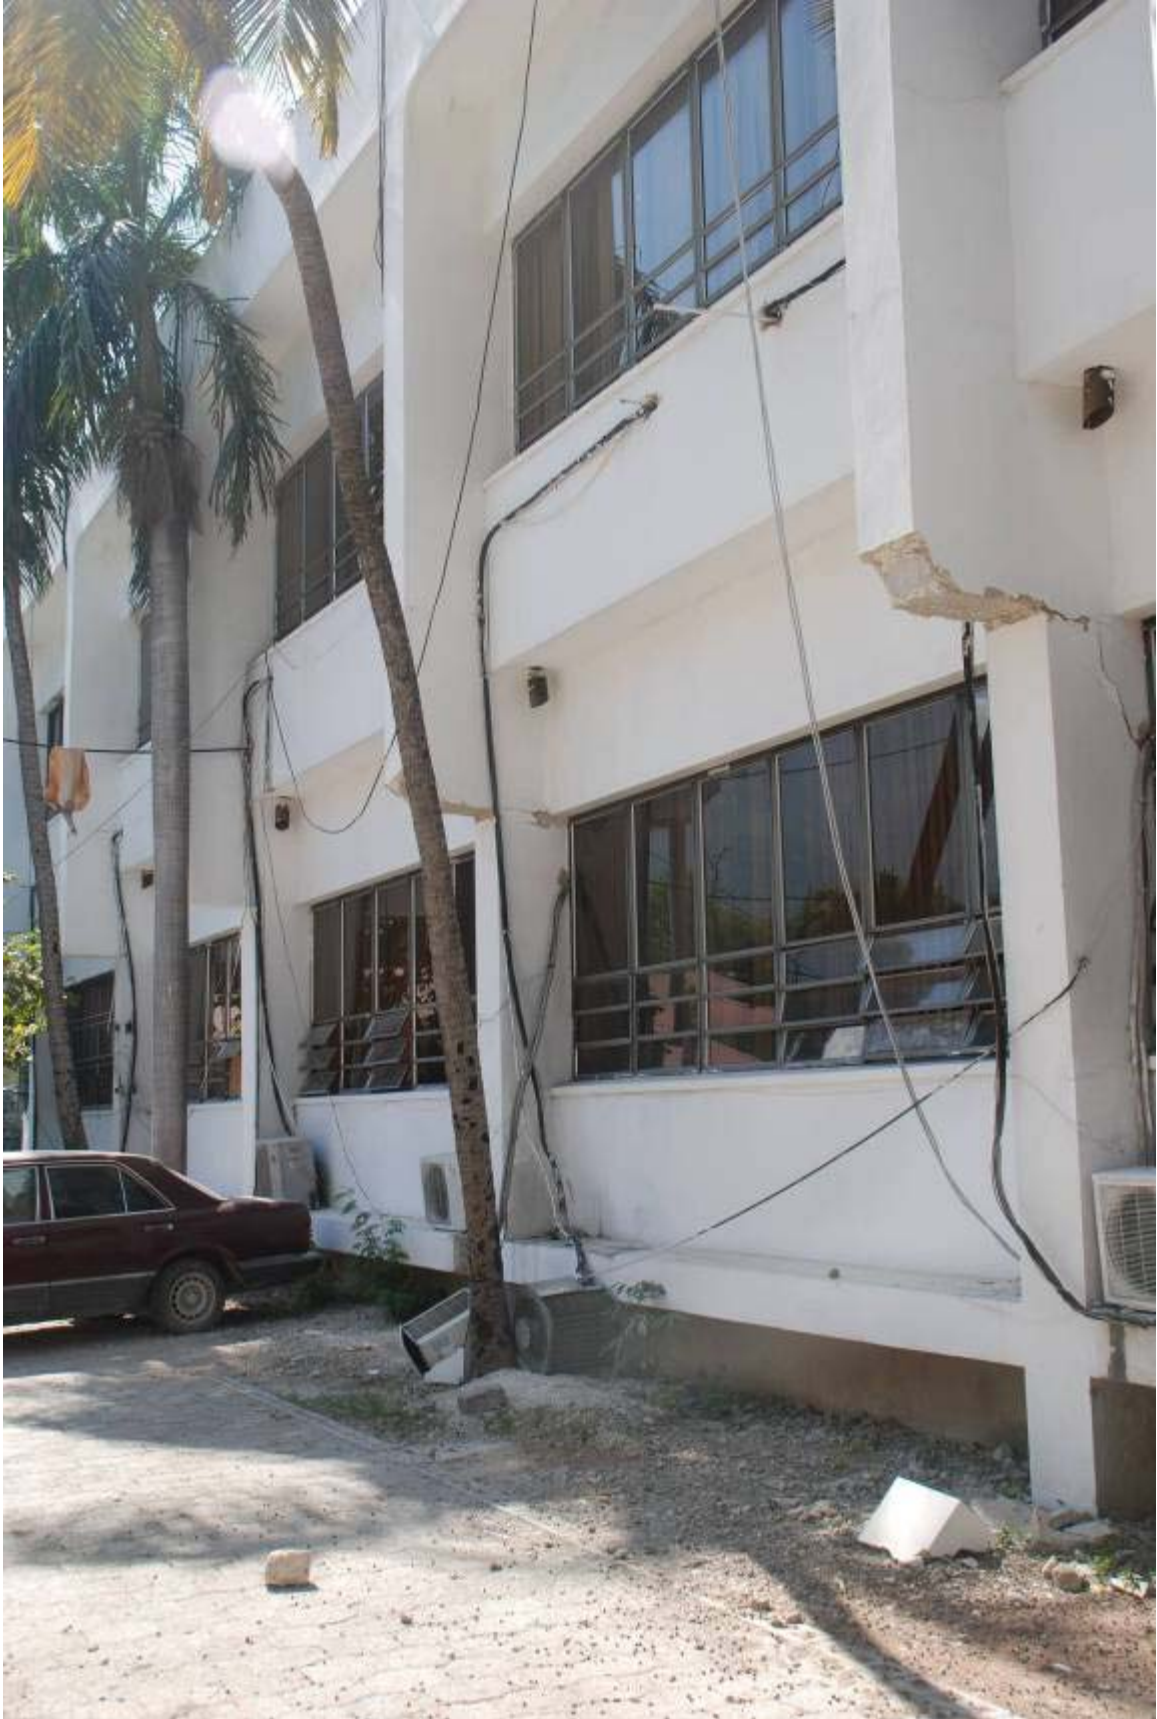
20) Ministry for Tourism

Ministry of Tourism is largely intact, however, evidence of exterior cracking and stress to foundation.

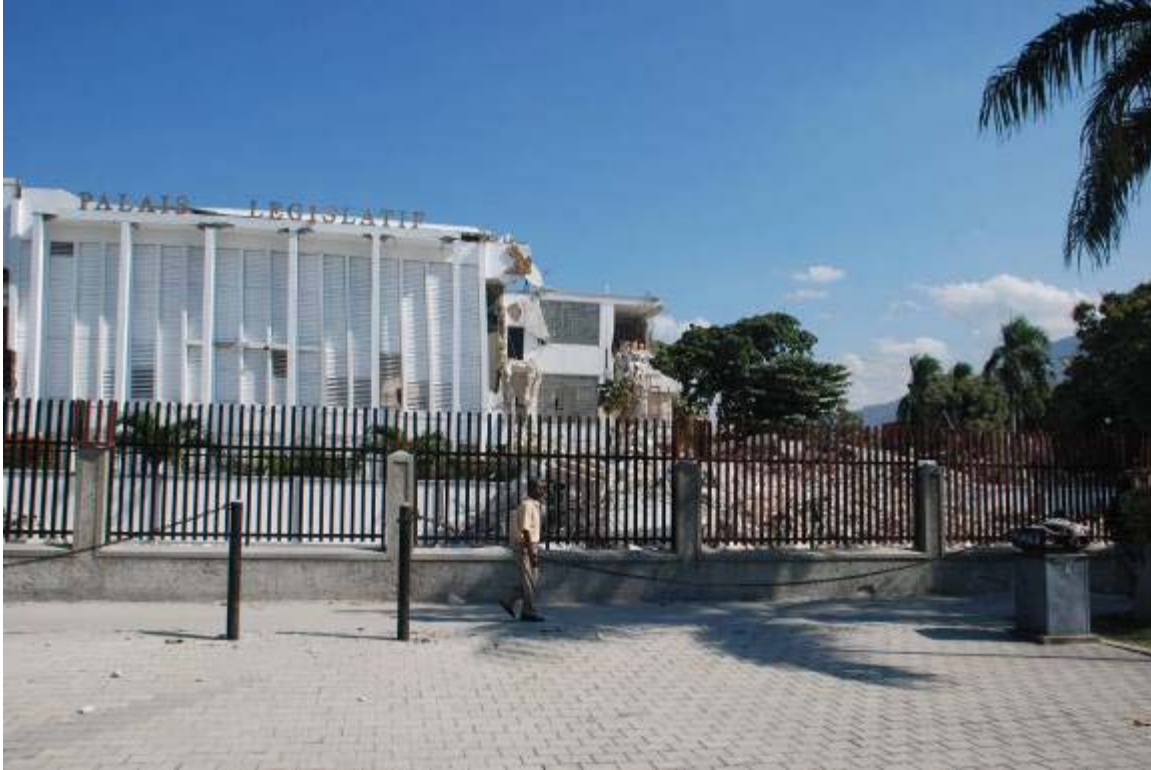
## 21) Parliament

Parliament suffered major structural damage with partially collapsed building.
