RE: GOH Infrastructure Matrix

1) Sight surveys of the structural integrity of 22 GOH office building were undertaken on January 20 & 21, 2010.

## Pictorial Inventory

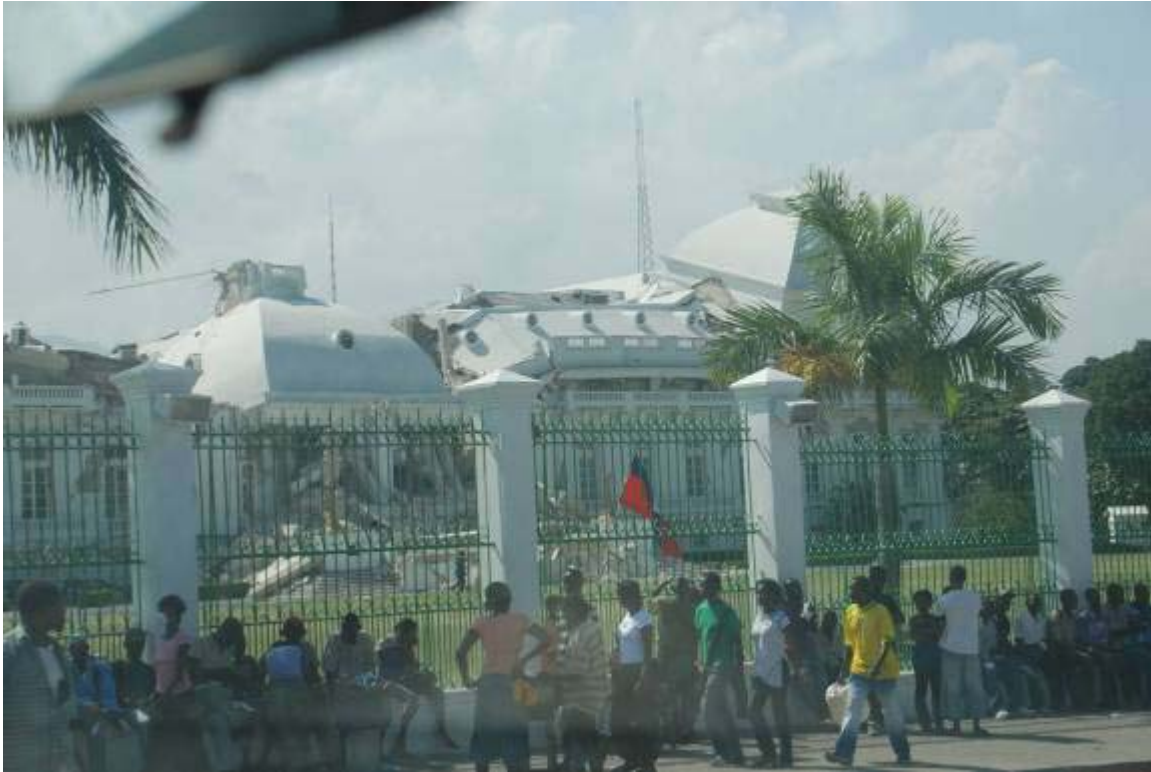
22) Presidential Palace

Pre

sidential Palace has collapsed in several sections
